Pineae Village Master Association

Level 2 Reserve Study

Type of Study	Update w/Site Visit
Date of Property Inspection	05/24/2023
Prepared By	Dale Gifford
Analysis Method	Cash Flow
Funding Goal	Full Funding

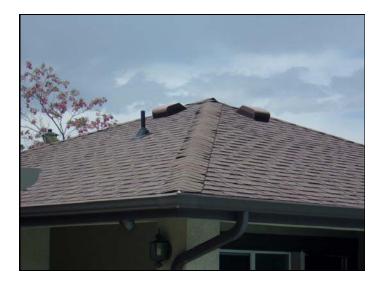
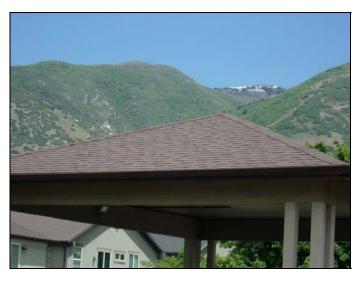
Comp #: 105 Roofs - Replace

The roofs are in good condition. We recommend funding to replace this component approximately every 20 - 25 years. Remaining life based on current age.

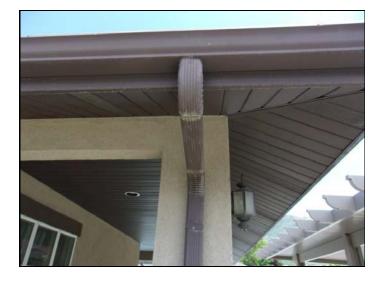
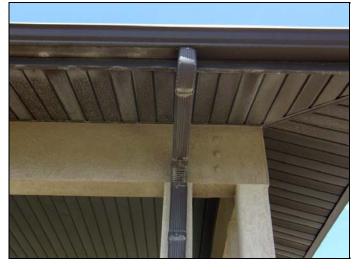
Comp #: 120 Rain Gutters/Downspouts - Replace

The rain gutters and downspouts are in good condition. We recommend funding to replace this component approximately every 25 - 30 years. Remaining life based on current age.

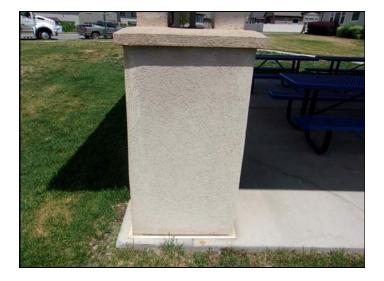
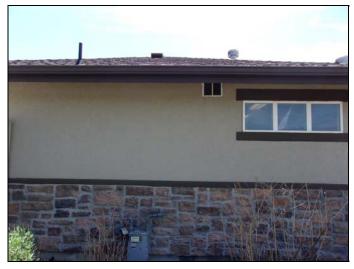
Comp #: 201 Stucco Surfaces - Repair/Repaint

The stucco surfaces are in fair condition. We recommend funding to repair/repaint this component approximately every 12 - 15 years. Remaining life based on current age and condition.

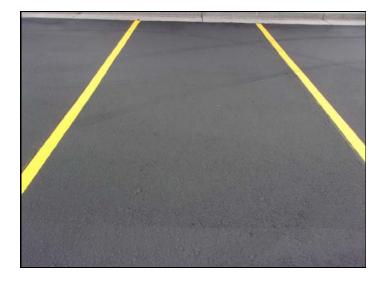
Comp #: 401 Asphalt - Major Rehab

The asphalt surfaces are in good condition. We recommend funding for a major rehab of this component approximately every 25 - 30 years. Remaining life based on current age.

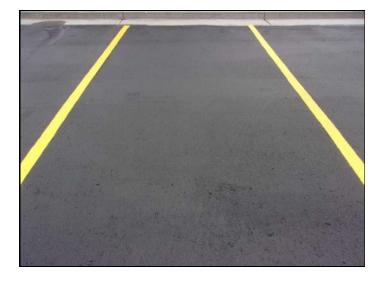
Comp #: 402 Asphalt - Seal Coat

The asphalt seal coat is in good condition. We recommend funding to seal this component approximately every 3 - 5 years. Remaining life based on current age.

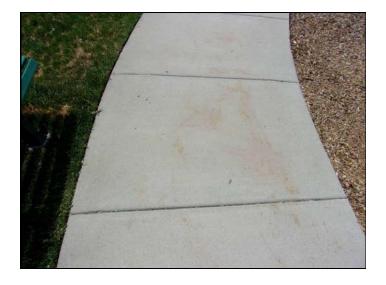
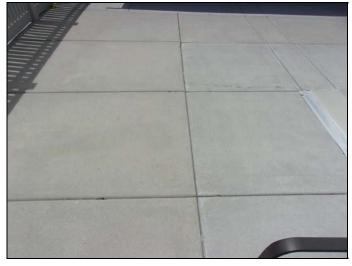
Comp #: 403 Concrete - Partial Repair/Replace

The concrete is in good condition. This component has an extended useful life under normal conditions. We recommend funding to make repairs and partially replace this component approximately every 10 years. Remaining life based on current age.

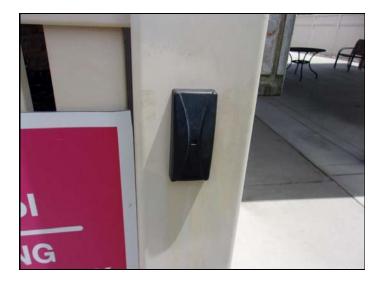
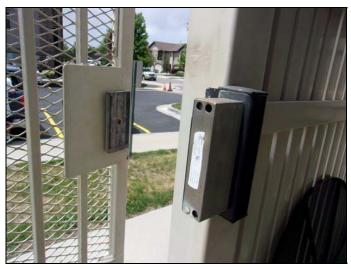
Comp #: 508 Access Control System - Replace

The access control system is in working condition. We recommend funding to replace this component approximately every 10 - 12 years. Remaining life based on current age.

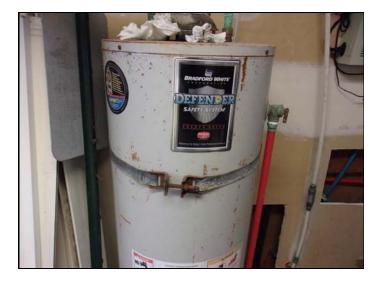
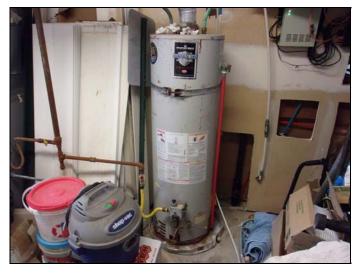
Comp #: 703 Water Heater - Replace

Due to the minimal cost of replacing this component, reserve funding is not appropriate. Replace as necessary as an operating expense.

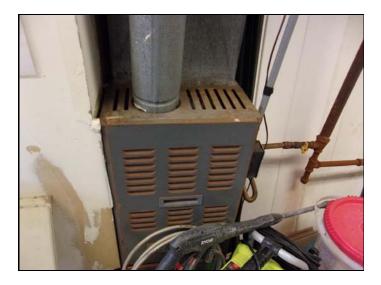
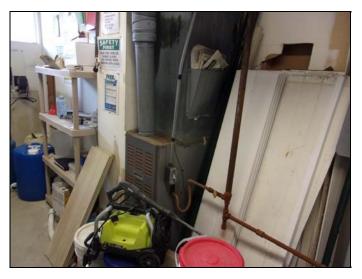
Comp #: 706 HVAC Furnace - Replace

The furnace is in working condition. We recommend funding to replace this component approximately every 20 years. Remaining life based on current age.

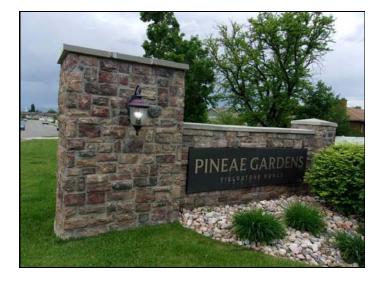
Comp #: 801 Monument Signs - Refurbish

The monument signs are in good to fair condition. We recommend funding to refurbish this component approximately every 15 - 20 years. Remaining life is based on current age.

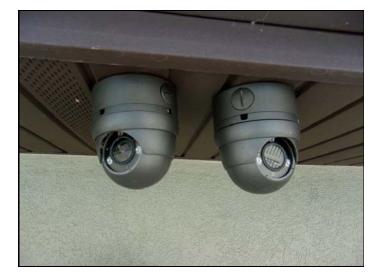
Comp #: 903 Security Camera System - Install

The security camera system is in working condition. We recommend funding to replace this component approximately every 10 - 12 years. Remaining life based on current age.

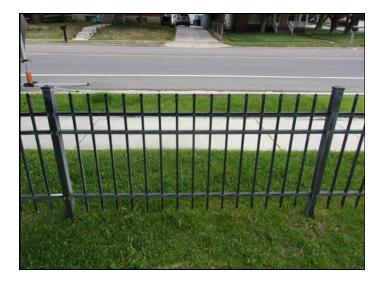
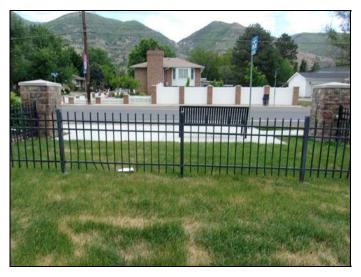
Comp #: 1002 Metal Fencing - Replace

The metal fencing is in good to fair condition. We recommend funding to replace this component approximately every 40 - 50 years. Remaining life based on current age.

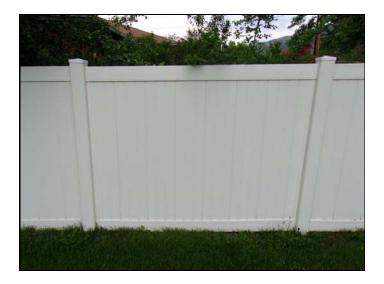
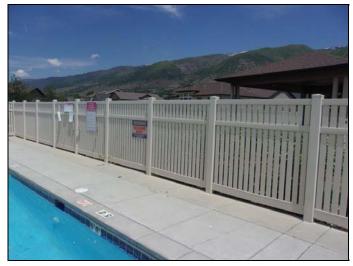
Comp #: 1008 Vinyl Fencing - Replace

The vinyl fencing is generally in good condition. We recommend funding to replace this component approximately every 25 - 30 years. Remaining life based on current age.

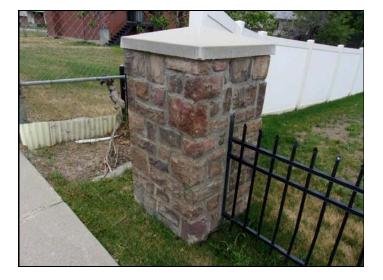
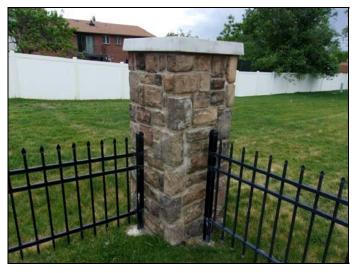
Comp #: 1090 Faux Stone Columns - Repair/Replace

The columns are in good to fair condition. We recommend funding an allowance to repair/replace this component approximately every 15 - 20 years. Remaining life is based on current age.

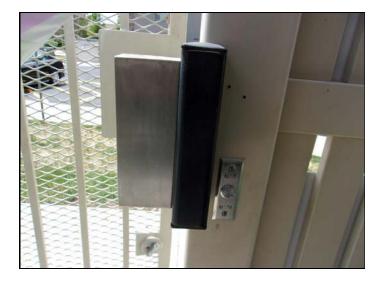
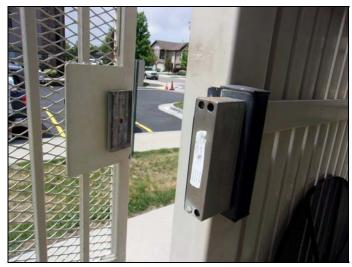
Comp #: 1090 Pool Gate - Replace

The gate is in good to fair condition. We recommend funding to completely replace this component approximately every 25 - 30 years. Remaining life based on current age.

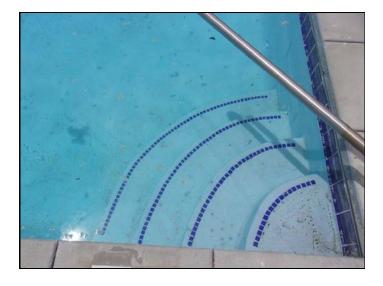
Comp #: 1101 Pool - Resurface

The pool surface is in fair condition. We recommend funding to resurface this component every 10 - 12 years. Remaining life based on current age.

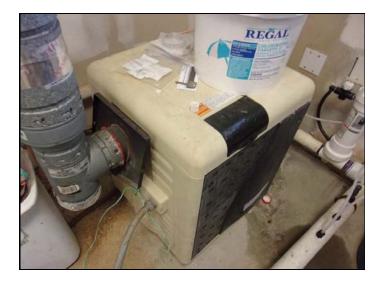
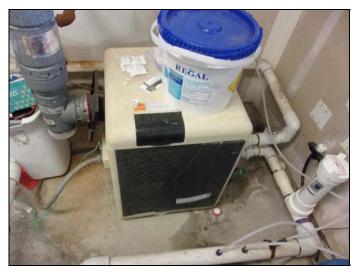
Comp #: 1104 Pool Heater - Replace

The pool heater is in working condition. We recommend funding to replace this component approximately every 12 years. Remaining life based on current age.

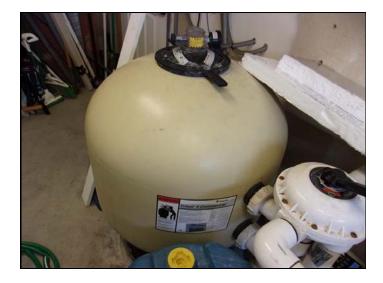
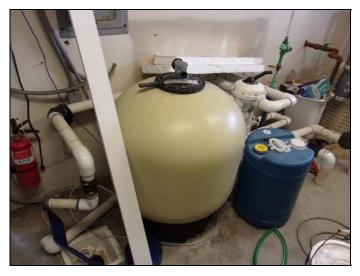
Comp #: 1107 Pool Filter - Replace

The pool filter is in working condition. We recommend funding to replace this component approximately every 12 - 15 years. Remaining life based on current age.

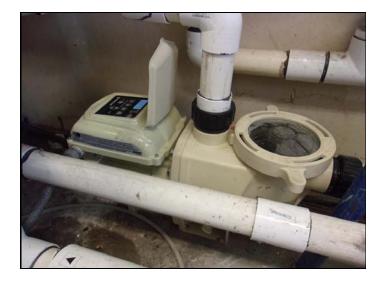
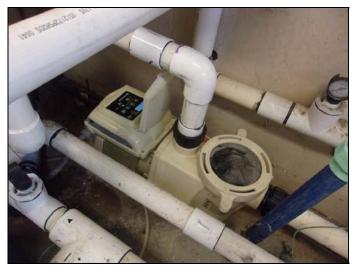
Comp #: 1110 Pool Pump - Replace

Due to the minimal cost of replacing this component, reserve funding is not appropriate. Replace as necessary as an operating expense.

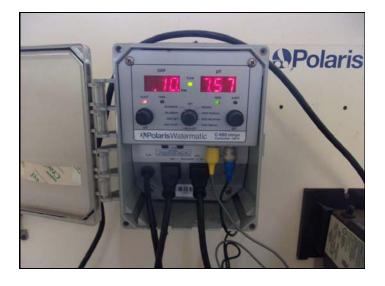
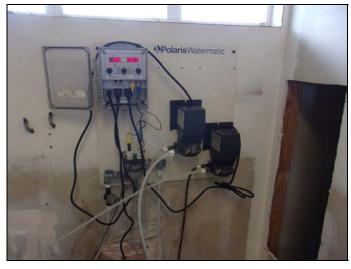
1111 Chemical Controller System - Replace Comp #:

The pool chemical controller system is in working condition. We recommend funding to replace this component approximately every 10 - 12 years. Remaining life based on current age.

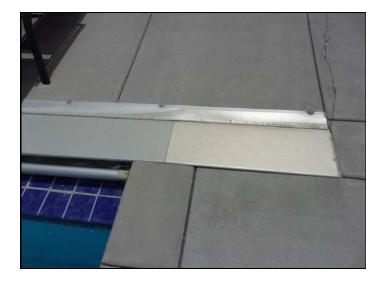
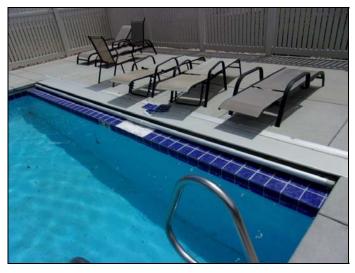
Comp #: 1112 Pool Cover - Replace

Unable to inspect this component at the time of the site visit. We recommend funding to replace this component approximately every 10 years. Remaining life based on current age.

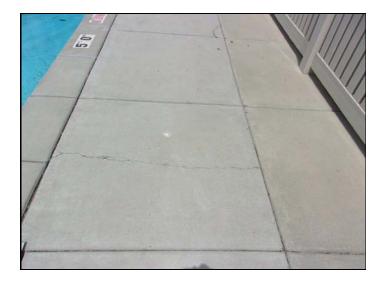
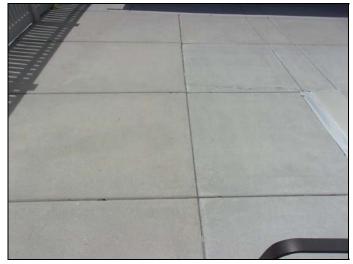
Comp #: 1116 Pool Deck - Replace

The pool deck is in good condition. We recommend funding to replace this component approximately every 40 - 50 years. Remaining life based on current age.
