Pineae Village Master Association

Level 2 Reserve Study

Type of Study	Update w/Site Visit
Date of Property Inspection	05/24/2023
Prepared By	Dale Gifford
Analysis Method	Cash Flow
Funding Goal	Full Funding

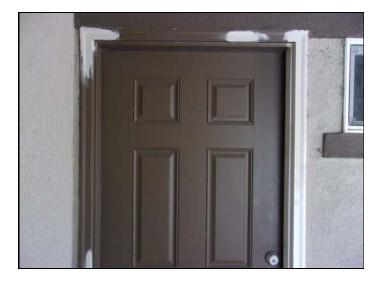
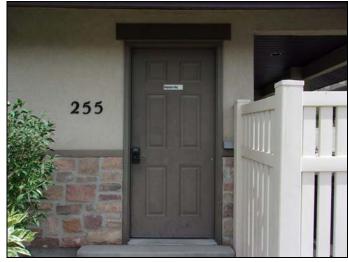
Comp #: 204 Doors - Repaint

Location:	Pool	Building
Quantity:	(3) D	oors
Life Expectancy: Best Cost:	N/A \$0	Remaining Life:
Worst Cost:	\$0

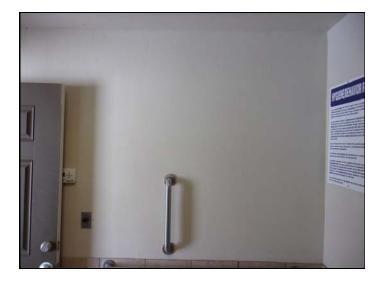
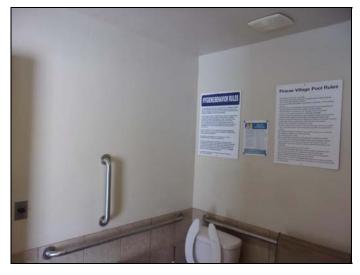
Comp #: 216 Restrooms - Repaint

Location:	Pool Building	General Notes:
Quantity:	Approx 400 SF	
Life Expectancy: Best Cost:	N/A Remaining Life: \$0	
Worst Cost:	\$0	
Courses of Informer	(in the second

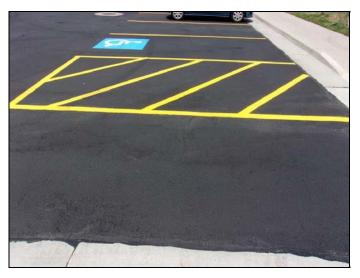
Comp #: 401 Asphalt - Major Rehab

Location:	Parking Areas		
Quantity:	Approx 12,235 SF		
Life Expectancy:	30 Remaining Life: 14		
Best Cost:	\$31,000		
Estimate for major rehab			
Worst Cost:	\$43,000		
Higher estimate			
Source of Information: CSL Cost Database

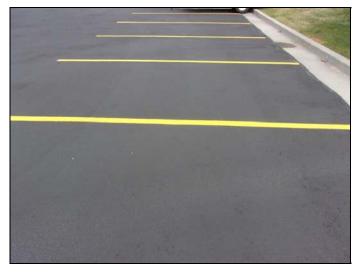
Comp #: 402 Asphalt - Seal Coat

Location:	Parking Areas		
Quantity:	Approx 12,235 SF		
Life Expectancy:	5 Remaining Life: 4		
Best Cost:	\$4,900		
Estimate for seal coat			
Worst Cost: \$5,000 Higher estimate			
Source of Information: Research with Client

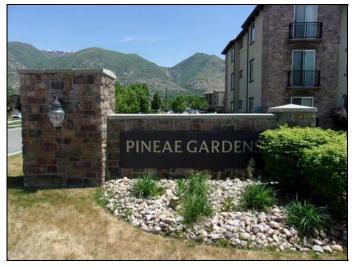
Comp #: 801 Monument Signs - Refurbish

Location:	Community Entrances		
Quantity:	(3) Signs		
Life Expectancy:	20 Remaining Life: 4		
Best Cost:	\$6,000		
Estimate to refurbish			
<i>Worst Cost:</i> Higher estimate	\$9,000		
Source of Information: CSL Cost Database

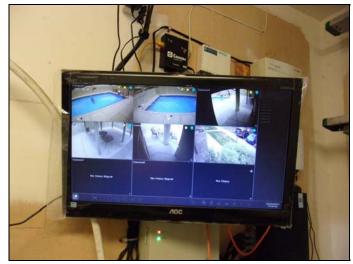
Comp #: 903 Security Camera System - Install

Location:	Pool Area	
Quantity:	(1) System	
Life Expectancy: Best Cost: Estimate to install	12 \$6,00	Remaining Life: 8 0
<i>Worst Cost:</i> Higher estimate	\$8,00	0

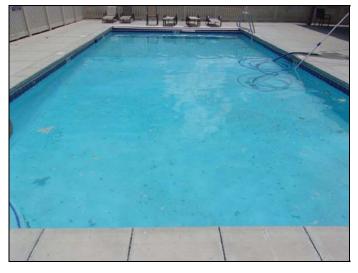
Comp #: 1101 Pool - Resurface

Location:	Pool Area		
Quantity:	(1) Pool		
Life Expectancy:	12	Remaining Life: 0	
Best Cost:	\$15,000		
Estimate to resurface			
Worst Cost:	\$20,0	000	
Higher estimate

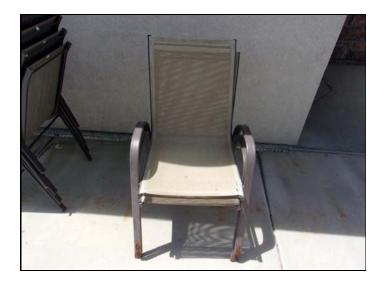
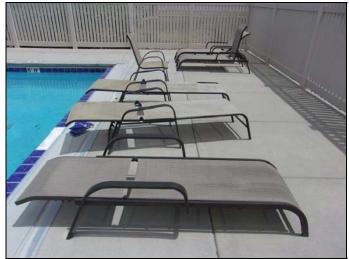
Comp #: 1121 Pool Furniture - Replace

Location: Pool Area

Quantity: Assorted Pieces

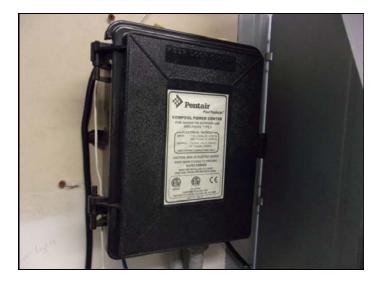
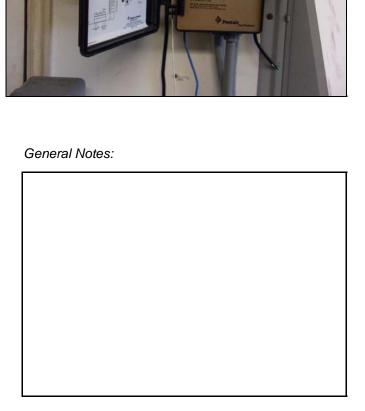
Comp #: 1190 Pool Control System - Replace

Quantity:(1) SystemLife Expectancy:15Remaining Life:0Best Cost:\$2,000Estimate to replace

Worst Cost: \$3,000 Higher estimate

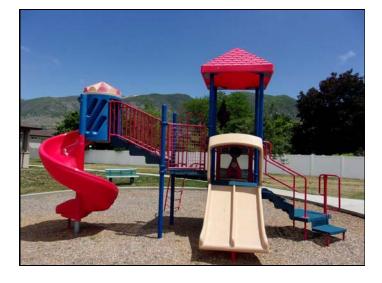
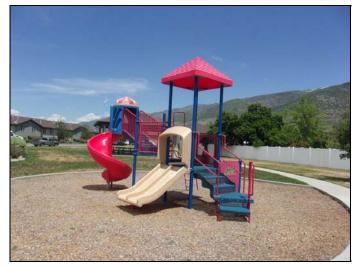
Comp #: 1301 Play Structure - East - Replace

Location:	Common Area		
Quantity:	(1) Structure		
Life Expectancy:	25 Remaining Life: 9		
Best Cost:	\$30,000		
Estimate to replace			
Worst Cost: \$40,000 Higher estimate			
Source of Information: CSL Cost Database

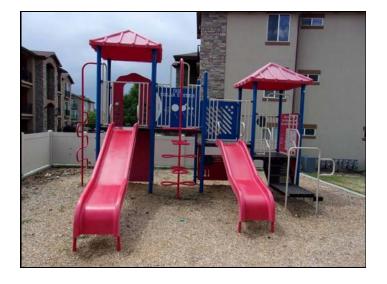
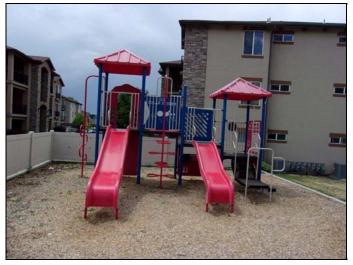
1301 Play Structure - West - Replace Comp #:

Location:	Common Area	
Quantity:	(1) Structure	
Life Expectancy:	25 Remaining Life: 12	
Best Cost:	\$35,000	
Estimate to replace		
<i>Worst Cost:</i> Higher estimate	\$45,000	
Source of Information: CSL Cost Database

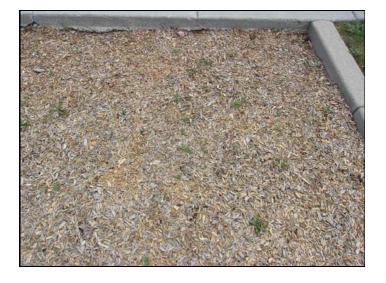
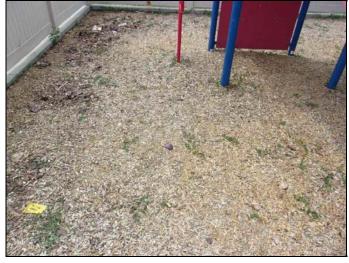
Comp #: 1303 Play Area Groundcover - Refill

Location:	Play Areas	
Quantity:	Approx 1,950 SF	
Life Expectancy: Best Cost: Estimate to refill	5 Remaining Life: 0 \$3,000	
<i>Worst Cost:</i> Higher estimate	\$4,000

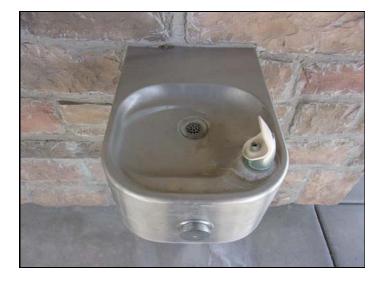
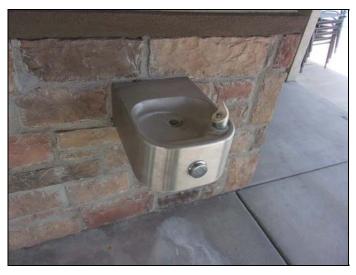
Comp #: 1304 Drinking Fountain - Replace

Location:	Pool Building	General Notes:
Quantity:	(1) Drinking Fountain	
Life Expectancy: Best Cost:	N/A Remaining Life: \$0	
Worst Cost:	\$0	
Source of Informa	ation:

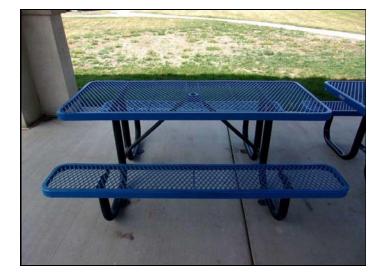
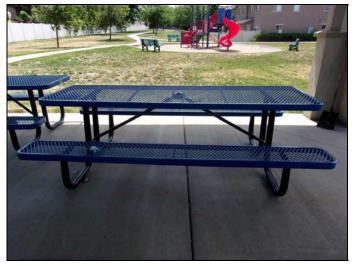
1306 Picnic Tables - Replace Comp #:

Location:	Pavilion Area	
Quantity:	(4) Picnic Tables	
<i>Life Expectancy: Best Cost:</i> Estimate to replace	15 <i>Remaining Life:</i> 10 \$5,000 æ	
<i>Worst Cost:</i> Higher estimate	\$6,000

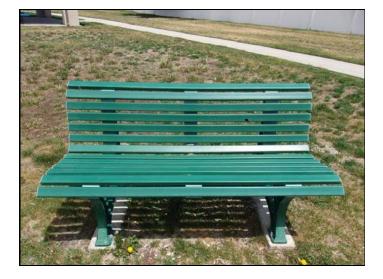
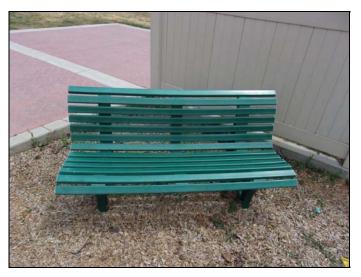
Comp #: 1307 Benches - Replace

Location:	Play Areas	
Quantity:	(5) Benches	
Life Expectancy:	15	Remaining Life: 3
Best Cost:	\$6,000	
Estimate to replace		
Worst Cost:	\$8,000	
Higher estimate

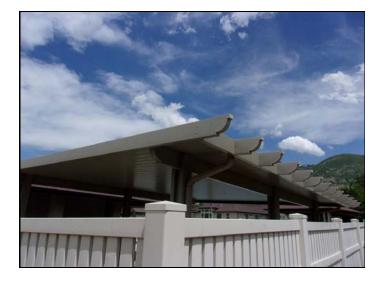
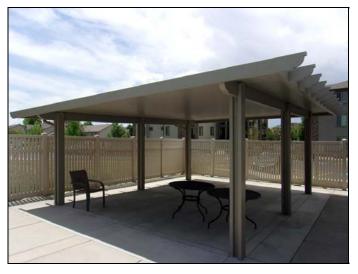
Comp #: 1309 Pool Shelter - Replace

Location:	Pool Area	
Quantity:	(1) Shelter	
Life Expectancy:	40	Remaining Life: 31
Best Cost: \$12,000 Estimate to replace		
<i>Worst Cost:</i> Higher estimate	\$17,0	000

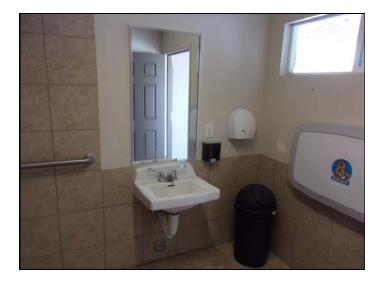
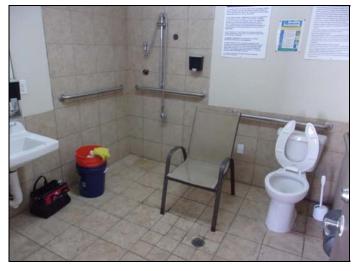
Comp #: 1413 Restrooms - Remodel

Location:	Pool Building			
Quantity:	(2) Restrooms			
Life Expectancy:	20 Remaining Life: 4			
Best Cost:	\$10,000			
Estimate to remodel				
	• · · · • • •			
Worst Cost	\$14,000

Worst Cost: \$14,000 Higher estimate

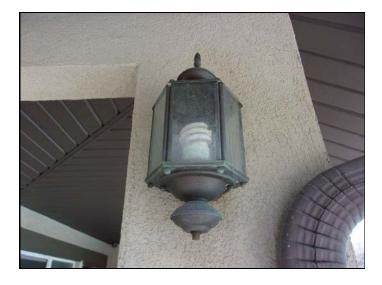
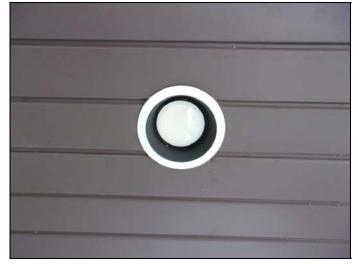
Comp #: 1602 Exterior Light Fixtures - Replace

Location:	Pool Building	General Notes:
Quantity:	(9) Fixtures	
Life Expectancy: Best Cost:	N/A Remaining Life: \$0	
Worst Cost:	\$0	
Source of Information:

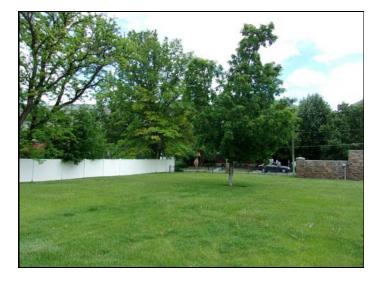
Comp #: 1812 Landscaping & Irrigation System - Renovate

Location:	Common Area		
Quantity:	Extensive SF		
Life Expectancy:	20 Remaining Life: 0		
Best Cost:	\$20,000		
Allowance to renovate			
	•••		
Worst Cost:	\$30,000		
Higher allowance			
Source of Information: CSL Cost Database

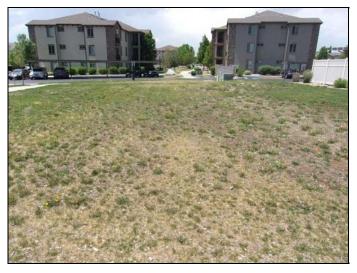
The landscaping and irrigation system are in good to poor condition. We recommend funding for an allowance to renovate this component approximately every 20 years. Remaining life based on current age and condition.
